**Thomas Douma**  
 Residential and Commercial Property Inspections  
 A Member of the Hawaii Inspection Group, Inc.  
 www.hawaiiinspectiongroup.com

**Scheduling: (800) 900-1239**  
 General Contractor's License # 26557      Phone: (866) 366-9006  
 E-mail:    tom@inspectiongroup.com

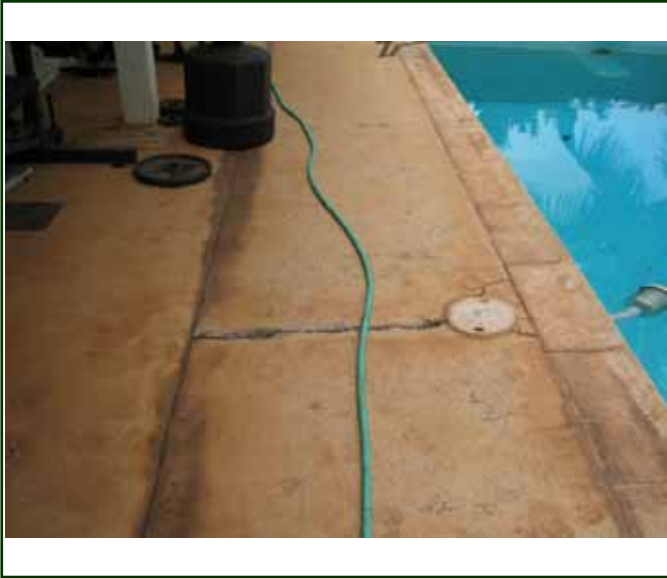
PHOTO 1: Cracks and separation at the pool decking

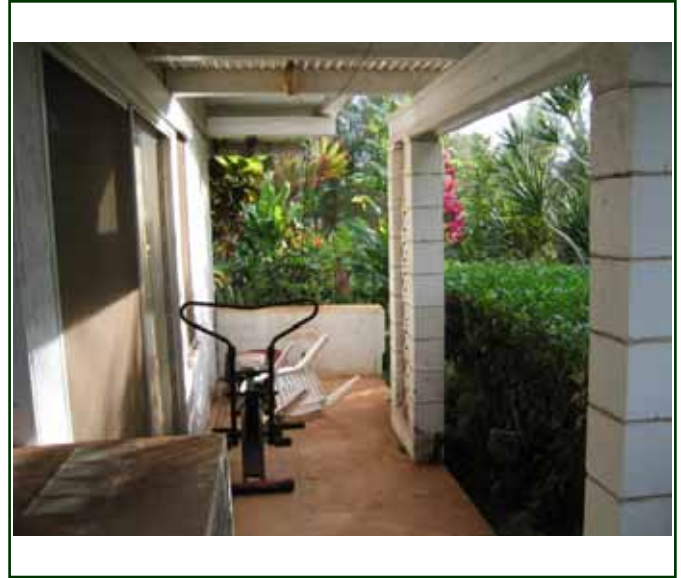
PHOTO 2: Rear patio slab and trellis

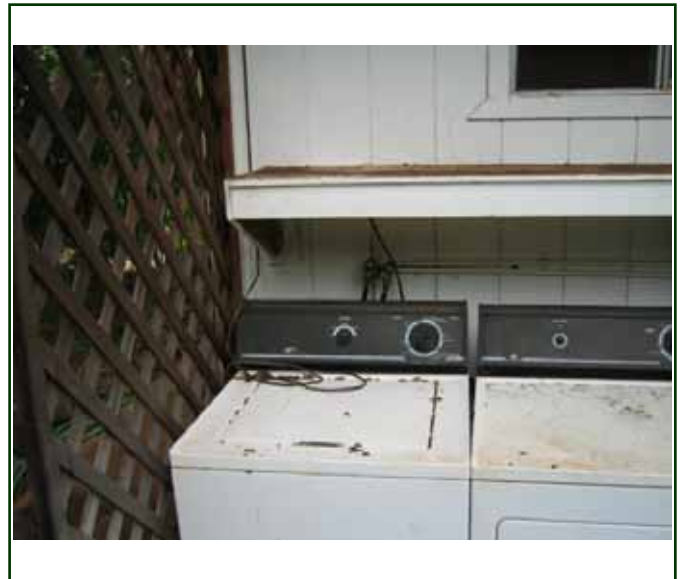
PHOTO 4: Leak at ohana washing machine faucet

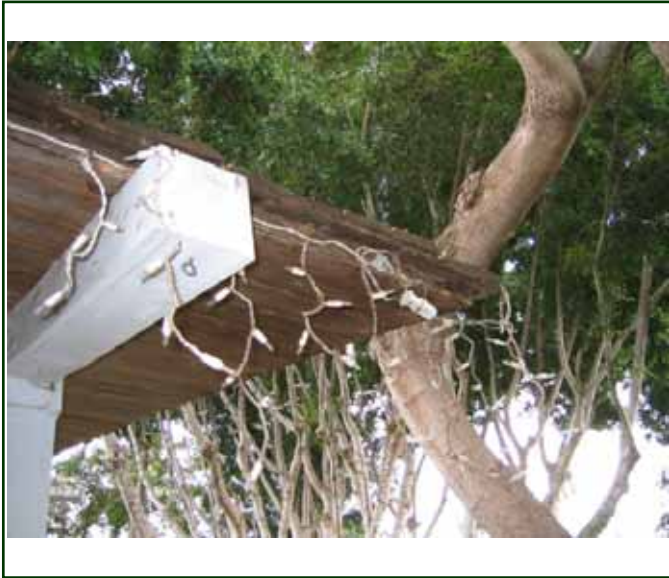
PHOTO 5: Insect and possible water damage to the eave at the left front corner of the ohana

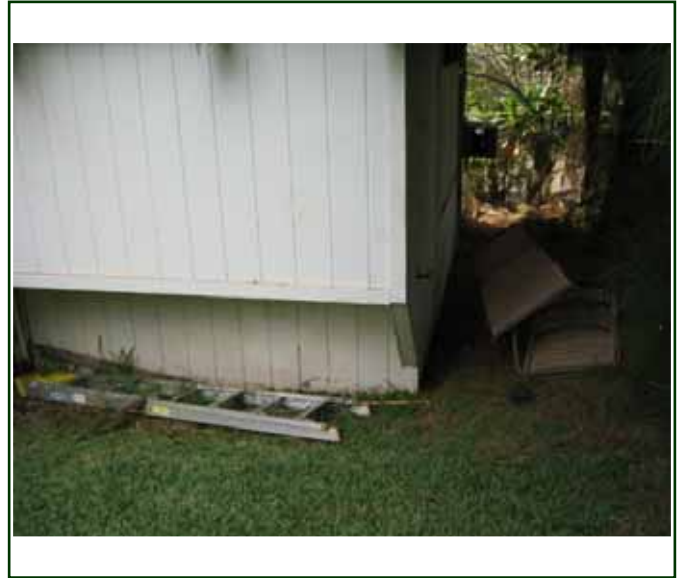
PHOTO 6: Dry rot damage to the exterior siding and a faulty grade at the left rear of the ohana

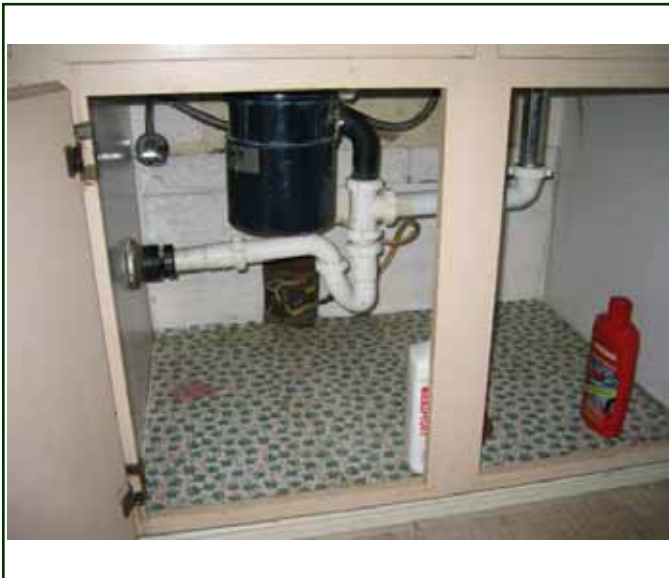
PHOTO 7: Exposed electrical splice at the disposal under the ohana kitchen sink

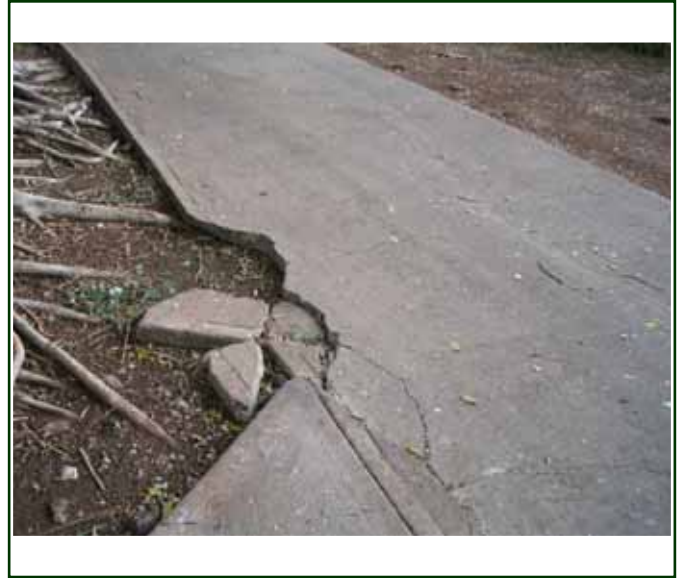
PHOTO 10: Root damage at the driveway

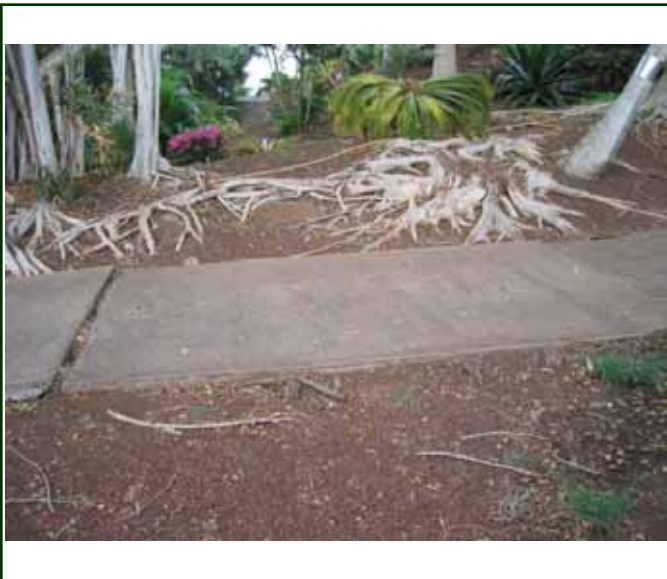
PHOTO 11: Root damage at the driveway

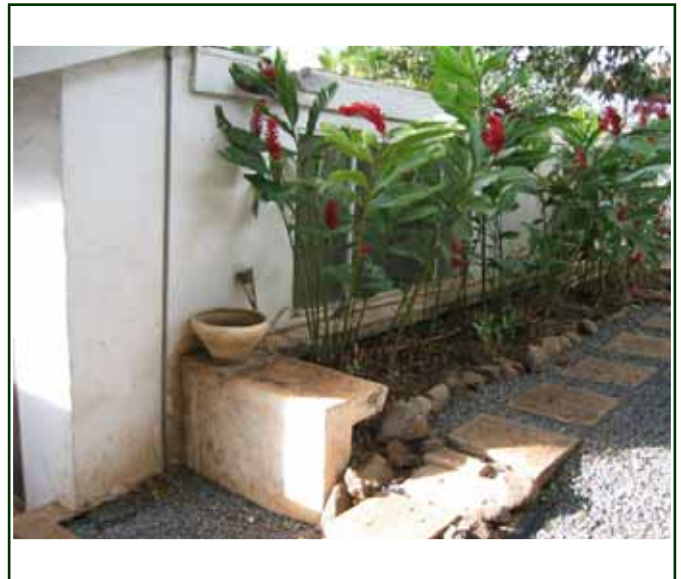
PHOTO 12: Faulty grade at the main house addition

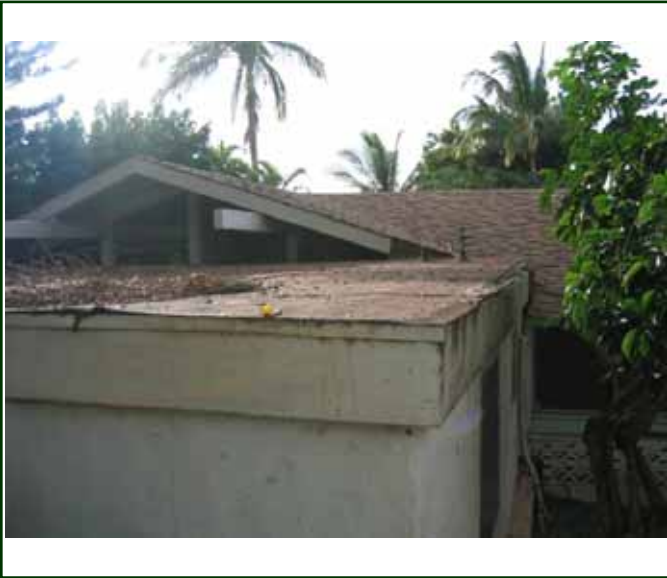
PHOTO 13: Flat roof section over the main house addition. Note damage to wood fascia board at the side and rear

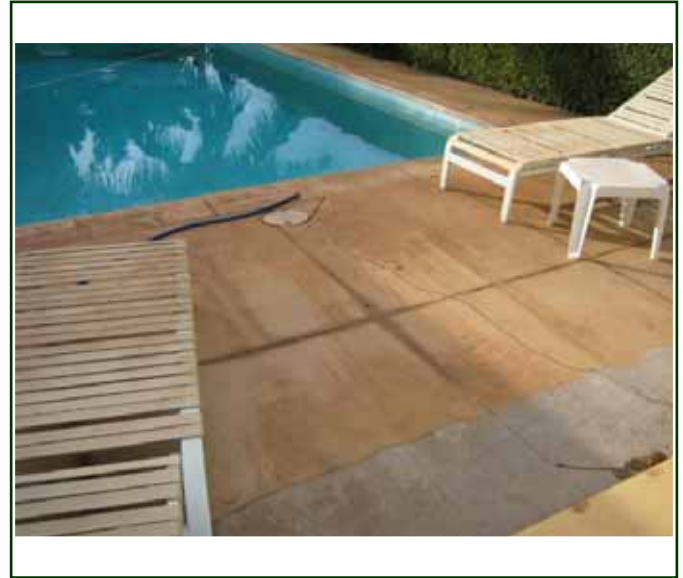
PHOTO 14: Cracks to the concrete deck at the pool
