The Purpose of the PCA (Property Condition Assessment) is to observe and report, to the extent feasible pursuant to the processes prescribed within the ASTM E2018-01 guidelines, on the physical condition of the subject property.

Property Address: 111 Main Street

City, State, Zip: Wailuku, Hawaii

Survey Date: November 4, 2014	Time: 8:30 am	Report No:
Inspection Address: 111 Main Street		
City, State, Zip: Wailuku, Hawaii	Aprox. Sq. Ft.	20,801
Client's Name: Client: Apartment Ventures, LLC	Listing Inspection: <input type="checkbox"/>	(Due within 90 days)
Agent's Name:	Phone:	
Office:	Email:	
Inspection Cost:	Add:	For: GET
Paid On Site: <input type="checkbox"/>	Check No.	Billing Fee: \$0.00
		Total: \$0.00

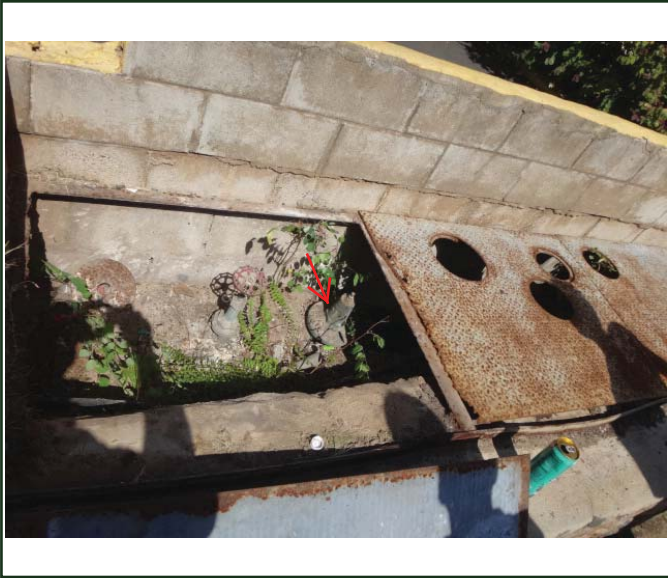
PHOTO 1:

- The water pressure to the units appeared low, and the pressure reducing valve may need repair or replacement. (photo 1)
 - The metal gutter system and discharge piping at the rear of the building was in various stages of disrepair. (photos 2 - 5)
 - The composition roll roofing over the exterior stairways at the left and right sides of the building was worn and deteriorated, and should be replaced or coated. (photo 12)
 - The metal flashing cap at the top of the wall on the right side of the building was bent, split, & deteriorated. (photo 6)
 - The street lights at the front entry drive were missing. (photo 7)
 - There was some bubbled and peeling waterproof coating found at the walkway areas on the 1st & 2nd floors at the front of the building. (photo 8)
-

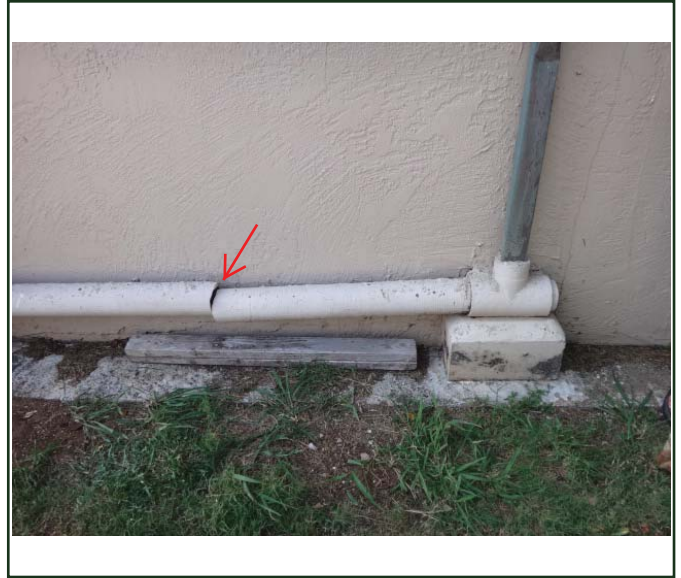
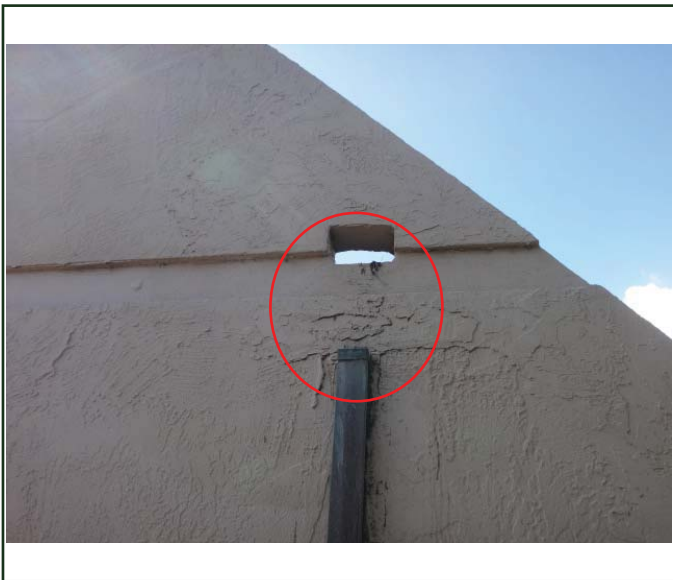
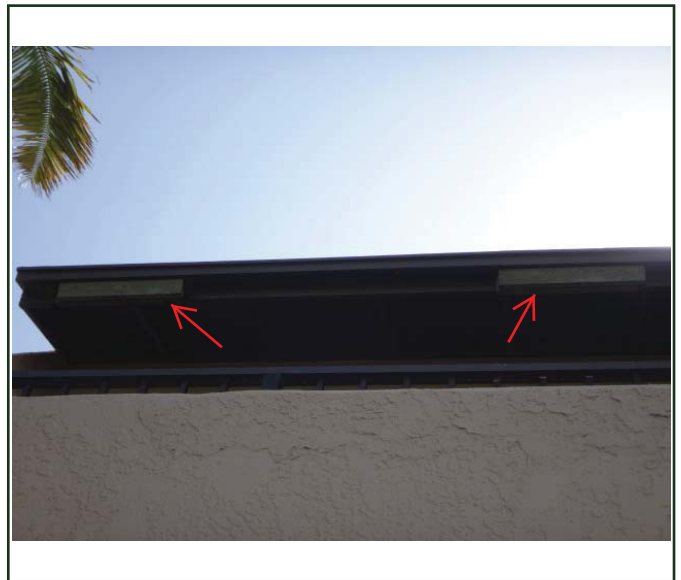
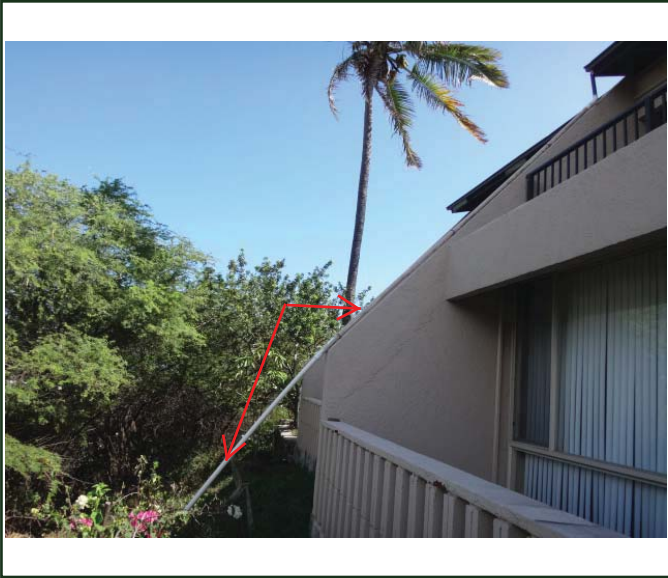
- d) There were metal gutters installed at the front and rear of the building, and while the gutters and piping at the front of the building was largely in good condition with no corrosion to the interiors, the gutters and piping at the rear of the building showed various deficiencies including broken or missing pipes and drain scuppers, irregular piping discharges and haphazard repairs to the gutter mounts, etc. (photos 2-5)

- a) Recommend further assessment of soil level and foundation at rear of building by a structural engineer for advice regarding any needed treatment and/or repairs. (photos 9-11)
- b) Recommend cleaning and repairs of gutter system, especially at the rear of the building. (photos 2-5)
- c) Recommend replacement or coating of composition roll roofing over stairways at left and right sides of building (less than 150sf) (photo 12)

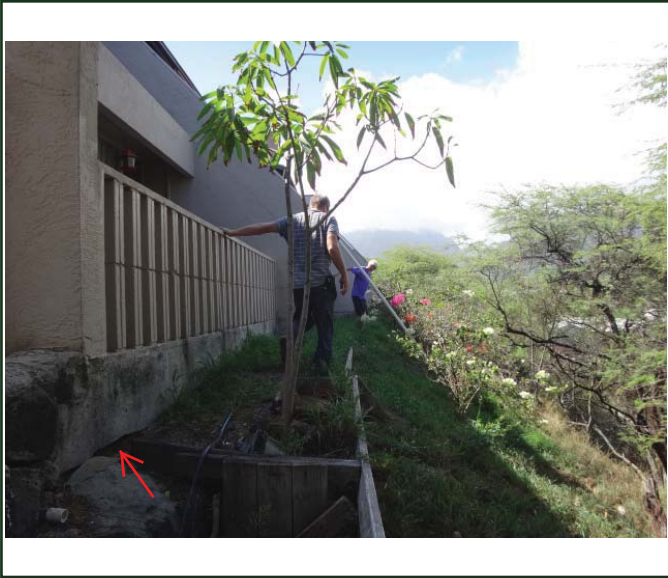
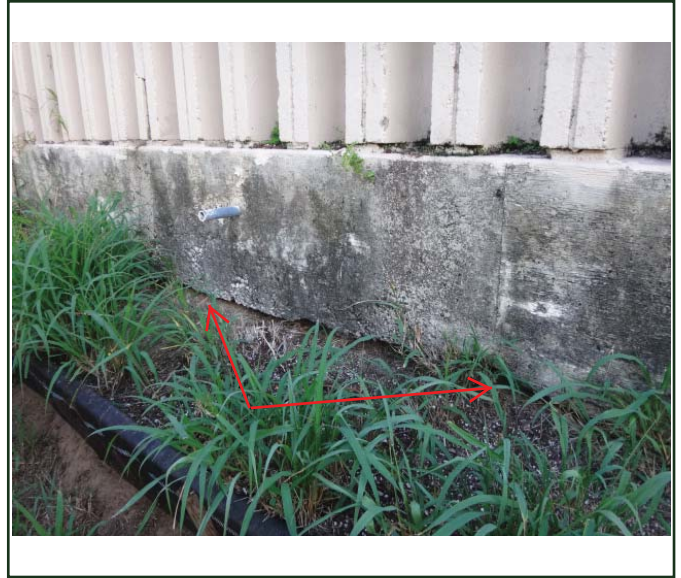
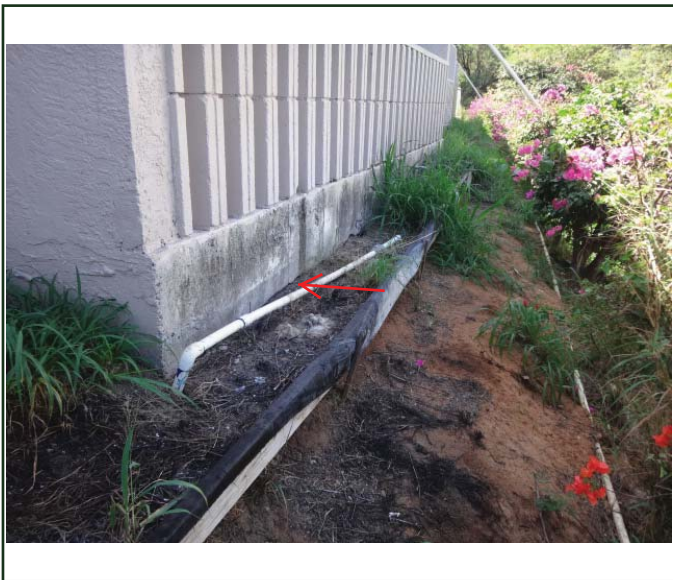
- The soil at the rear of the building was eroded, with areas of soil washout and undermining seen at the bottom of the foundation in areas. Recommend further assessment by a structural engineer for advice regarding any needed treatment and/or repairs. (photos 9-11)

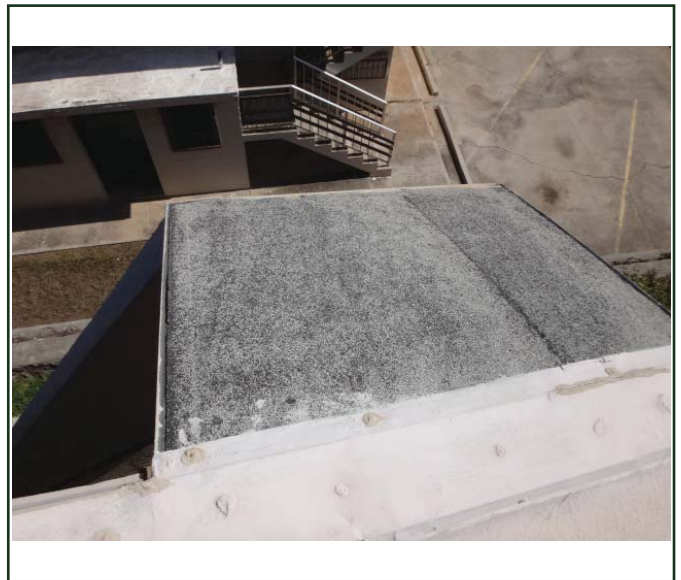
PHOTO 12:

- c) The composition roll roofing installed on top of the stairways at the left and right sides of the building was worn with missing aggregate and exposed fiberglass fabric. Recommend replacement at this time (less than 150sf) (photo 12)

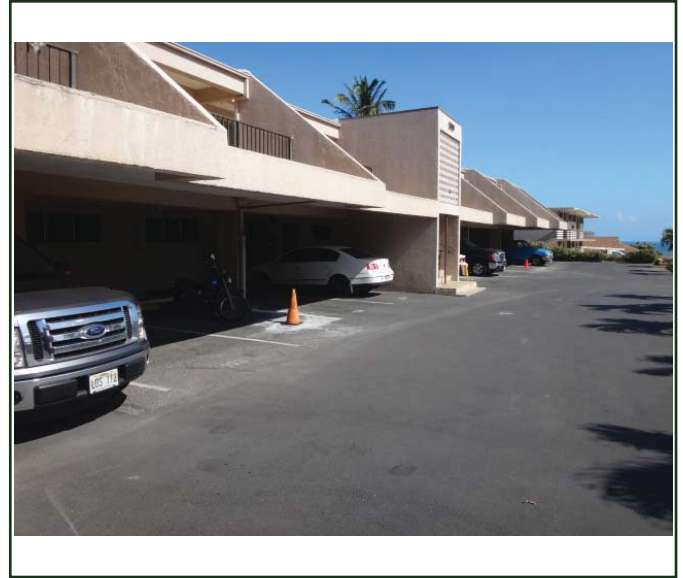
PHOTO 18:

The surface parking was asphalt with 16 marked parking spaces. The asphalt parking areas were in fair condition. Timely sealcoating is recommended to avoid damage to the asphalt. (photo 18)

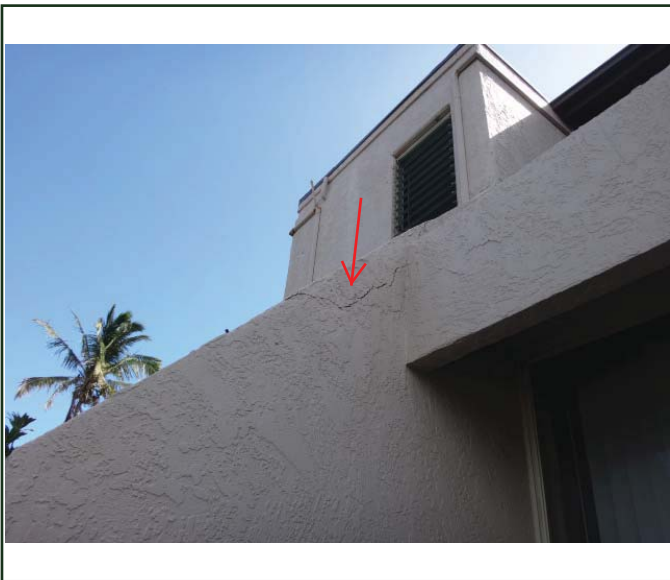
PHOTO 19:

There was some relatively minor spalling found at some vertical wall areas at the rear of the building. (photo 19)

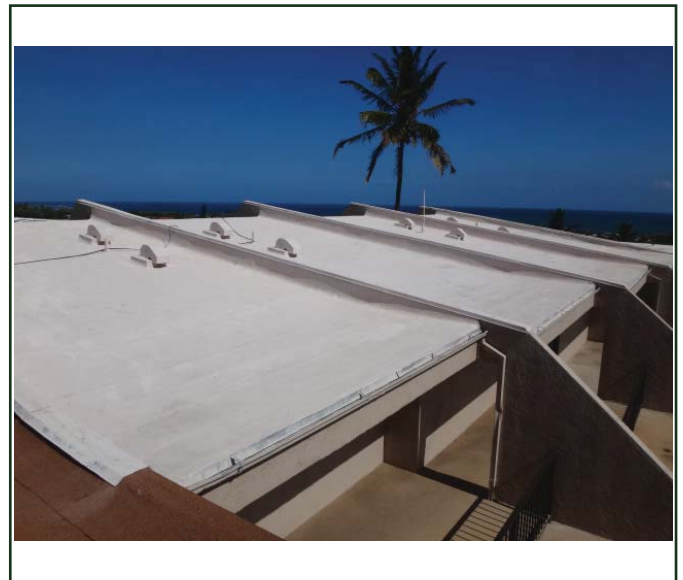
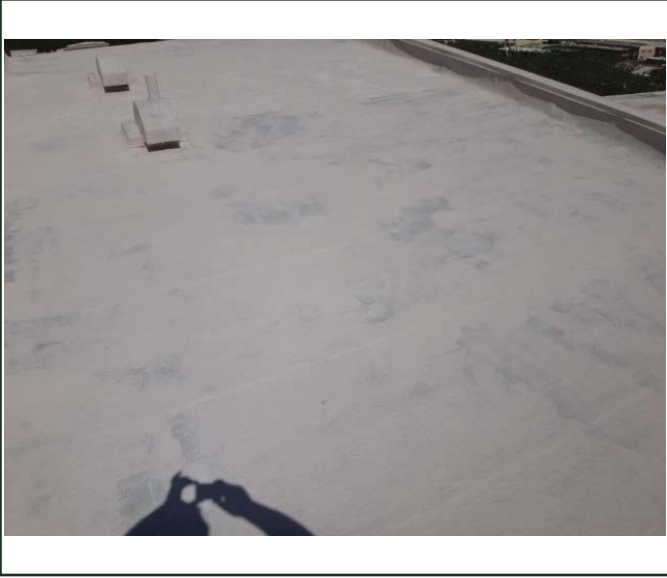
- a) While the membrane roof had been coated and in generally good condition, there were some areas toward the East end of the building where the coating appeared thinner than the rest of the membrane roof, and showed some shadowing through the coating. (photos 20 & 21)

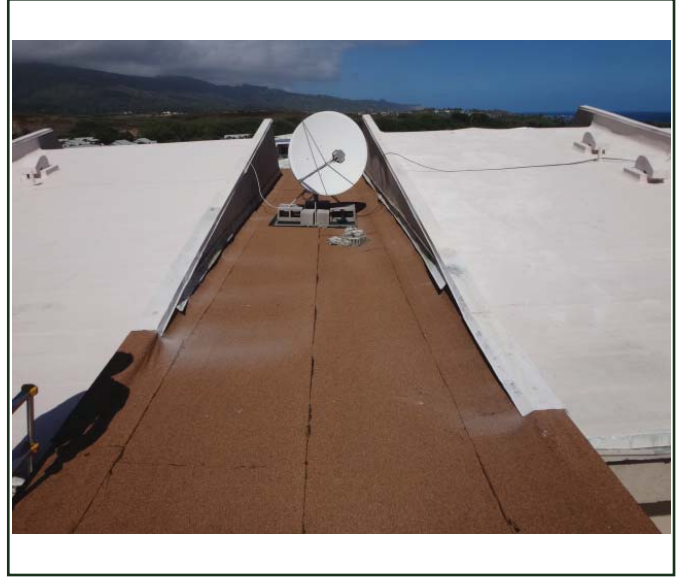
PHOTO 22:

- b) There was some composition roll roofing installed at the center of the building and appeared in good condition, and an estimated age of approximately 10yrs. Recommend that the roofing be coated at time of next membrane coating to prolong useful life expectancy of the roofing. (photo 22)

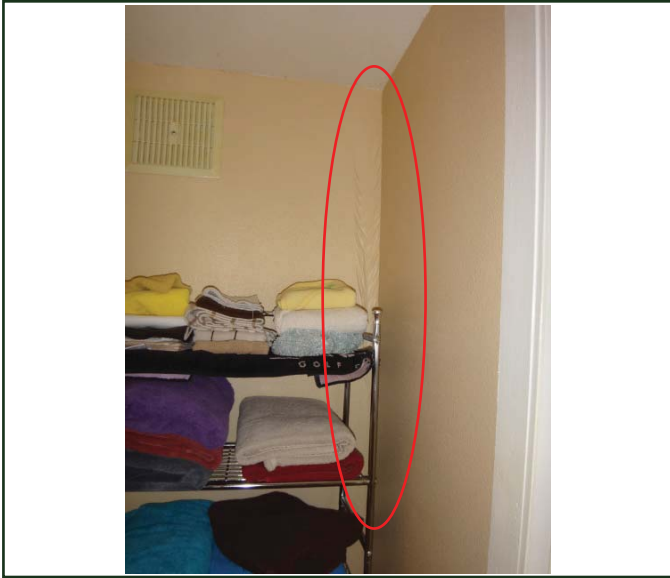
PHOTO 25:

The walls appeared in serviceable condition where visible inside the building. There was one wall area to the right of the toilet in the bathroom of Unit 104 where the paint on the wall was bubbled and drooping from an apparent leak from the unit above, however the wall area was dry at time of our visit. (photo 25)

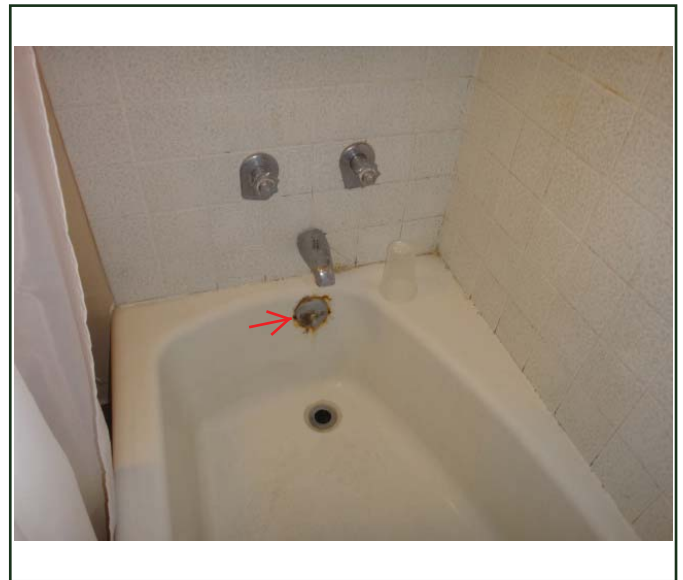
PHOTO 28:

Many of the cast iron bathtubs within the units showed some visual evidence of corrosion at the overflow plates and in some cases around the drain rings; while none of the areas were severe at time of our visit, we recommend the areas be treated, repaired, or touched up to help prevent further corrosion to the tubs which could result in water damage. (photo 28)
