The Purpose of the PCA (Property Condition Assessment) is to observe and report, to the extent feasible pursuant to the processes prescribed within the ASTM E2018-01 guidelines, on the physical condition of the subject property.

This document is a PCR (Property Condition Report) written with the purpose of describing the conditions of the property described herein as per guidelines established by the ASTM Standard E2018-01 for conducting a PCA (Property Condition Assessment).

The property is comprised of one two story poured concrete structure.

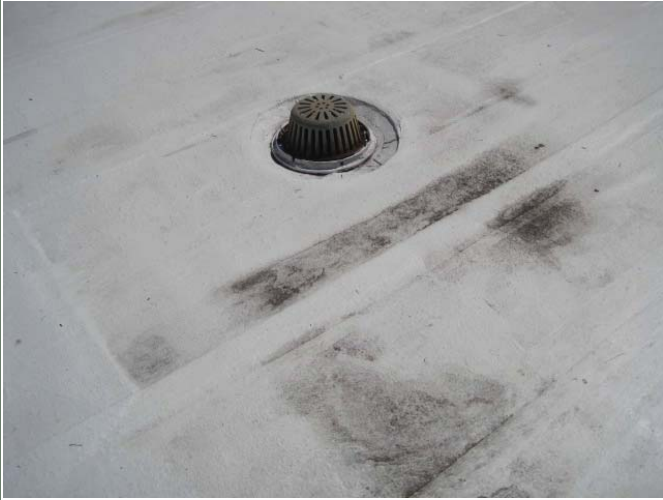
There may be leaking at one of roof drains, and I recommend repairs at this time. See picture 5

PHOTO 5: Possibly leaking roof drain

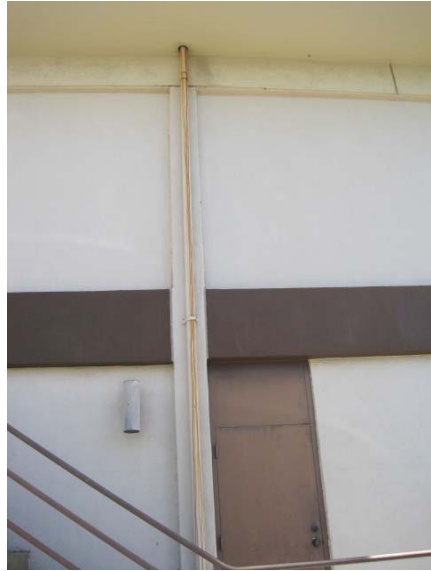
PHOTO 6: Possibly leaking roof drain downspout

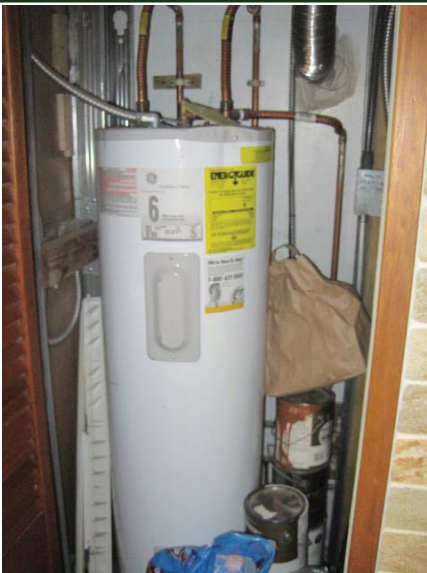
There is a GE 40 gallon water heater for the first floor that is in good condition. See picture 7

PHOTO 7: Lower floor water heater

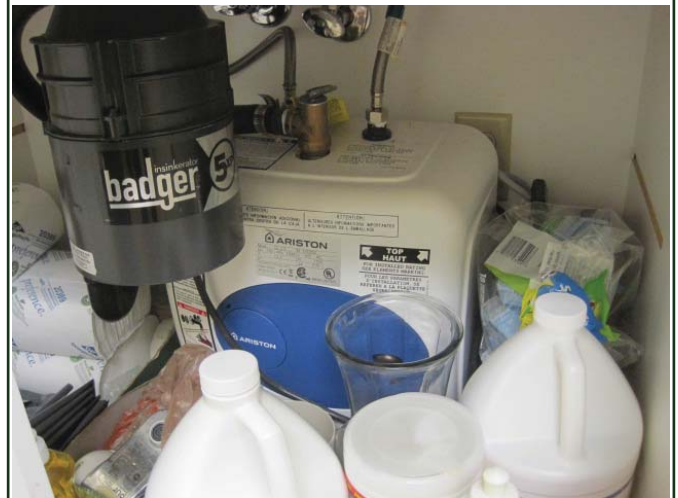
There is an Ariston on-demand electric water heater on the second floor under the kitchen sink in good condition. See picture 8

PHOTO 8: Ariston on demand water heater

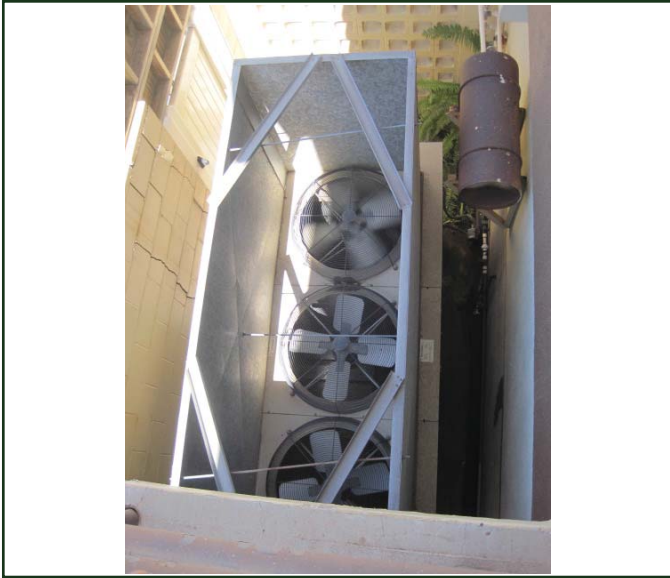
PHOTO 9:

The McQuay chiller appears in good condition, and I talked to Alltemp AC who services this unit. It is of 25 ton capacity, sufficient for cooling the building, and we had it turned on the entire time during the inspection. See picture 9

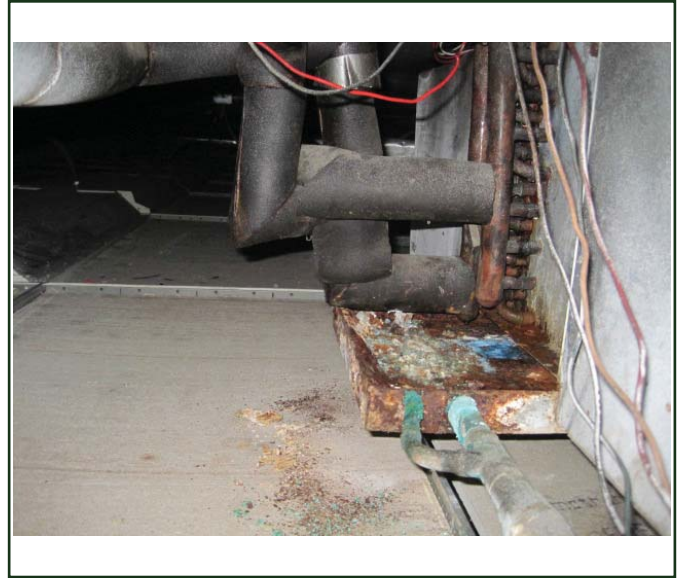
- a) One lower floor air handler is rusted and shows evidence of recent leaking.
- b) Spalling Damage to concrete at the main entrance, rear stair landing, and AC chiller CMU block enclosure

The 4 air handlers on the upper floor appeared to be in good condition, and are being serviced by Alltemp AC who change the filters and inspect these units on contract. The four downstairs units are in fair to poor condition, and one unit is extensively corroded and needs to be replaced at this time. See picture 10 thru 12

PHOTO 10: Corroded AC air handler, first floor ceiling

The lower floor air handlers need a more thorough evaluation by a licensed HVAC contractor as these are not under maintenance contract and appear to need repairs and servicing.

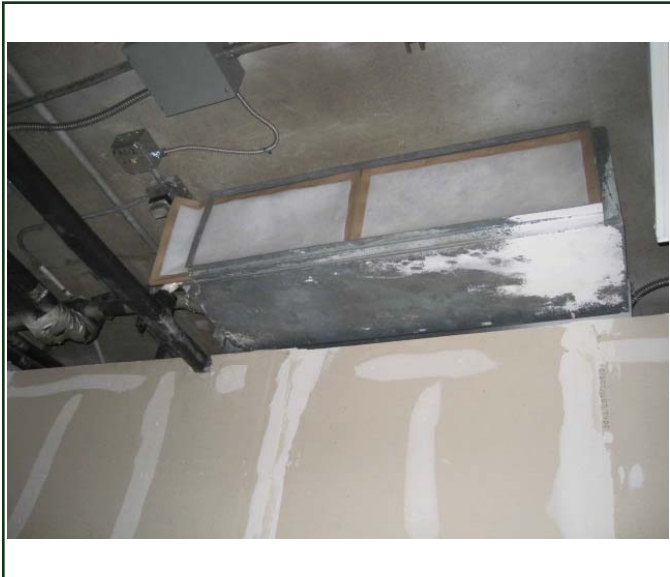
PHOTO 11: Lower floor AC air handler, typical of 4

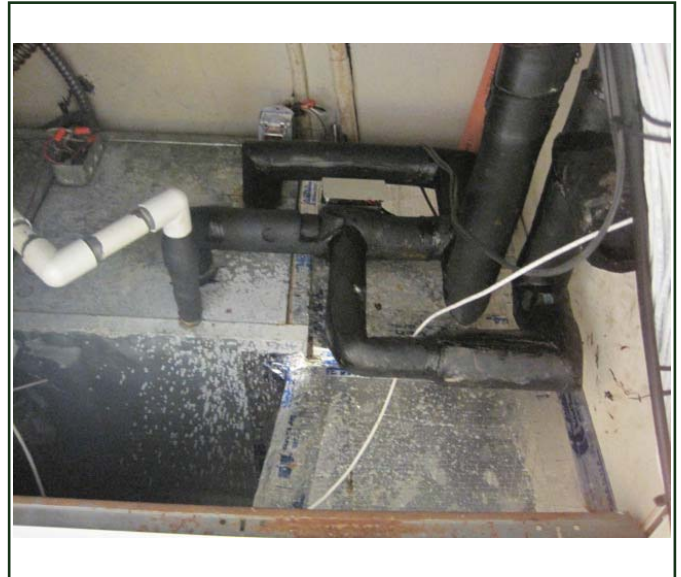
PHOTO 12: Upper floor AC air handler typical of 4

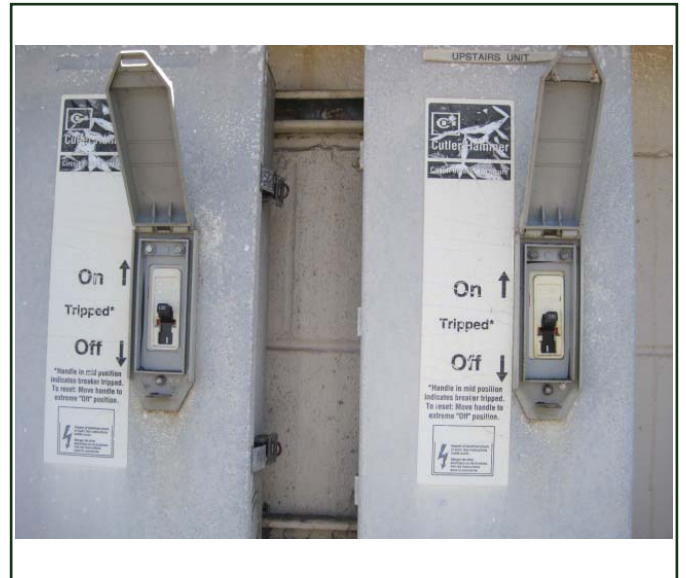
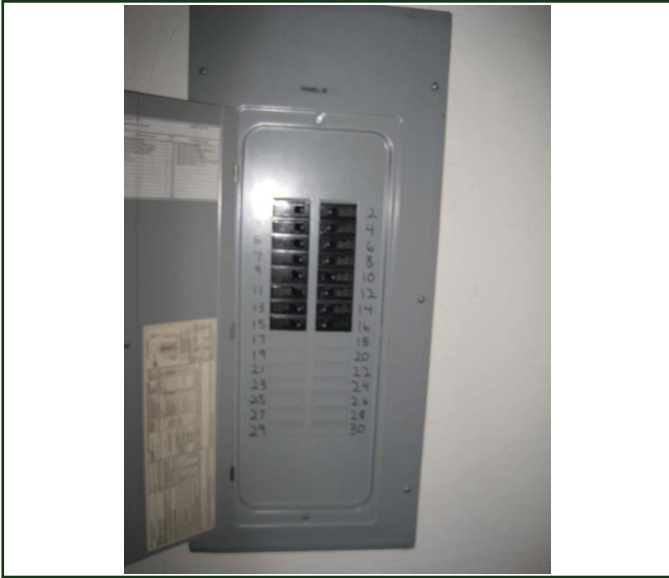
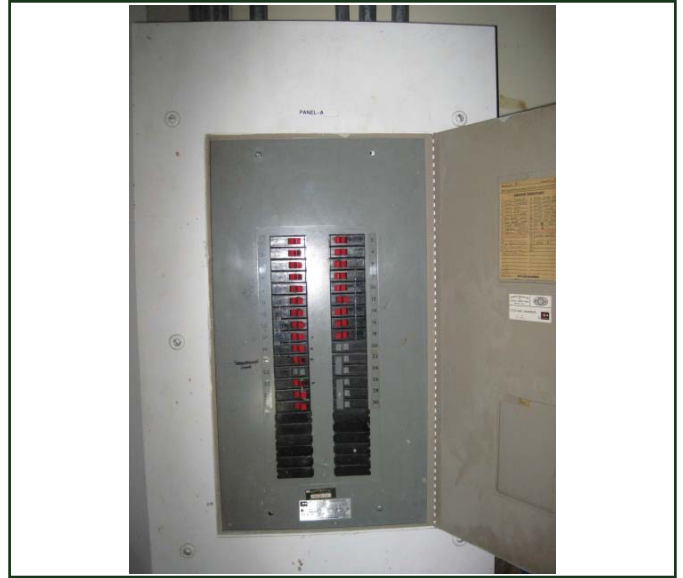
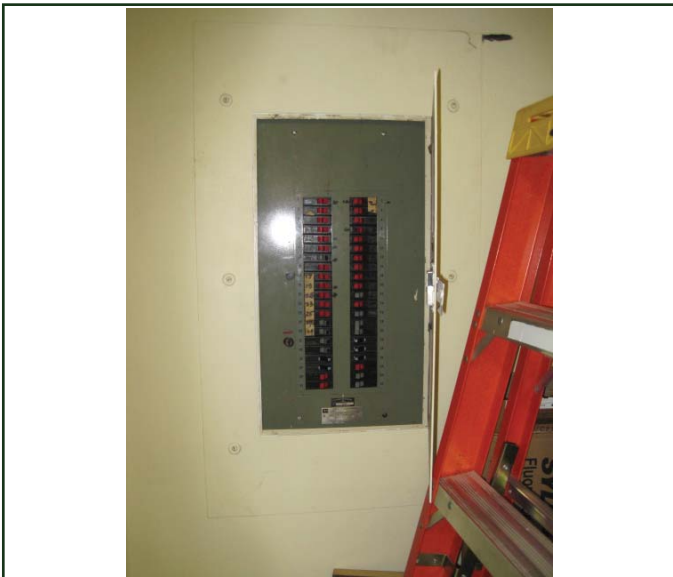
The building power for interior power runs through an exterior chase to two panels on the exterior wall with circuit breaker disconnects showing 200 amp ratings. These in turn provide power subpanels inside the building, one for the top floor and two for the lower floor. We turned all the power to all the lights and AC while performing the inspection and found no problems. See pictures 16 thru 19

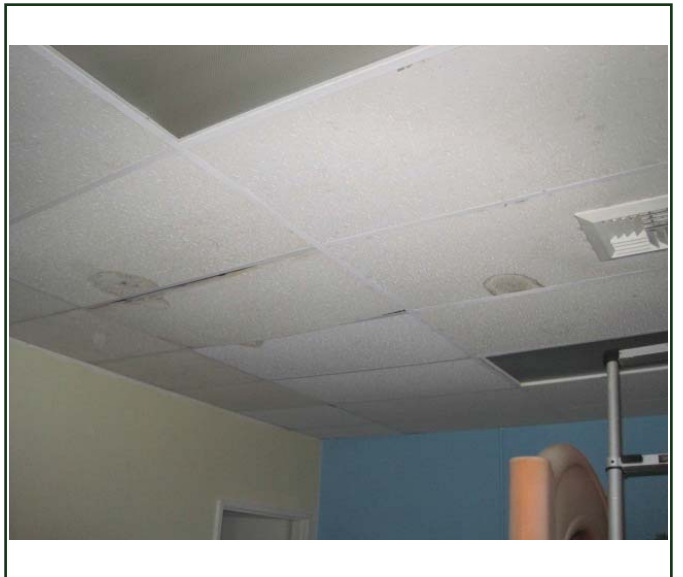
The ceilings were fiberboard drop panels with electrical wiring and AC ducts in the drop spaces and some panels were damaged or missing. Some water stains were noted, though no leaking was present at the time of the inspection. See picture 20

PHOTO 20: Downstairs ceiling tiles

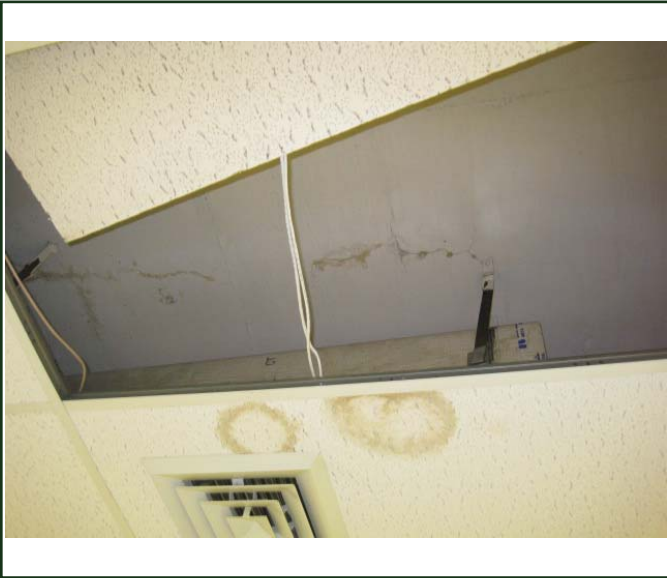
At the upstairs rear wall, some ceiling panels have been removed exposing the underside of the roof slab where epoxy has been applied apparently to correct leaking. This area is under where we believe a roof drain could be leaking. See picture 21

PHOTO 21: Upstairs ceiling tiles showing water damage and attempts at leak repair

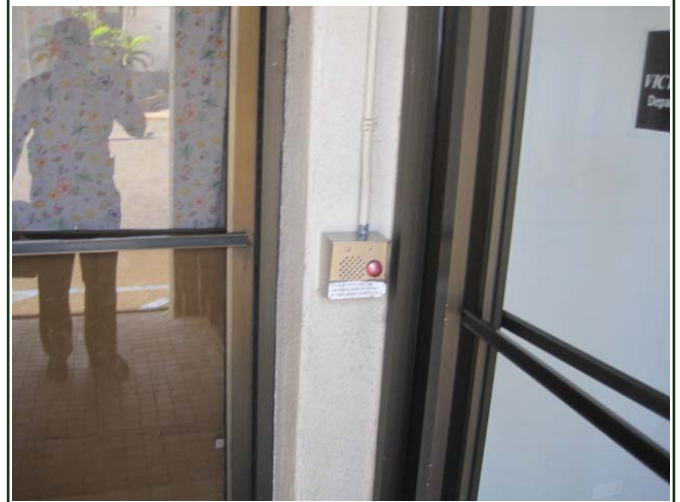
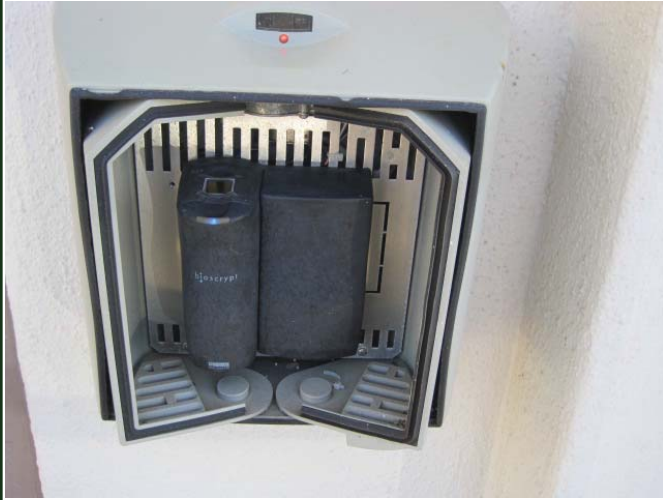
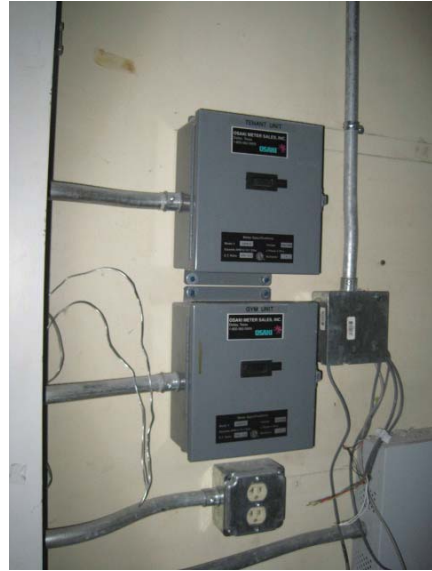
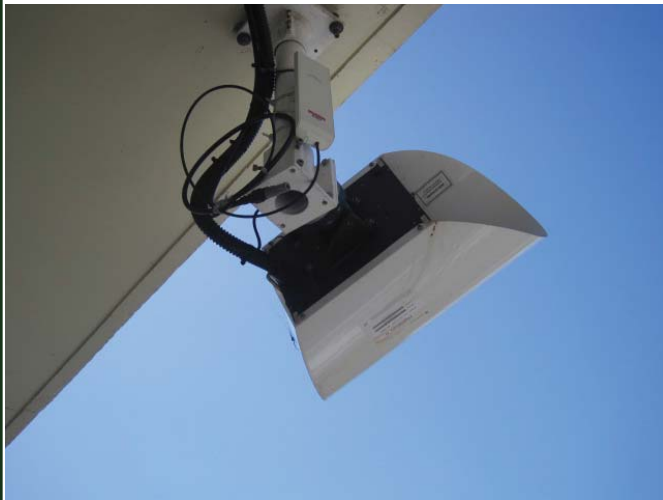
The upstairs space has a door access control system, exterior parking lot surveillance camera, and interior alarm monitoring system that appear to be tenant specific. These system are not within the scope of the PCA. See pictures 28 thru 31

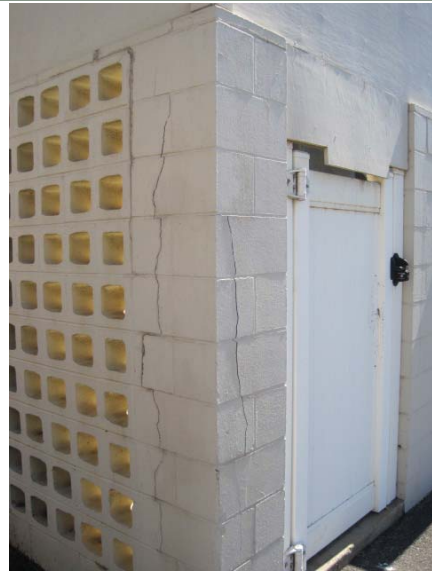
The building is a poured in place two story structure with concrete slab foundation and concrete slab roof. No visible evidence of settlement was found, but some small areas of concrete spalling were noted at the front entry, rear stair landing, and the air handler CMU enclosure. These areas need repair at this time, see pictures 32 thru 34

The front entry door to the lower floor has a metal/glass door whose closer is not working correctly and needs repair. The exterior door to the AC chiller enclosure is damaged and needs repair to be opened. See picture 32

PHOTO 32: Spalling at AC chiller enclosure

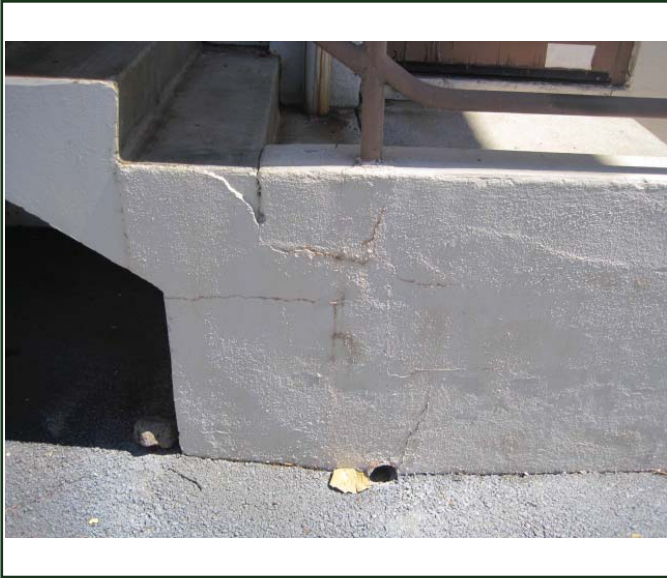
PHOTO 33: Spalling at rear steps

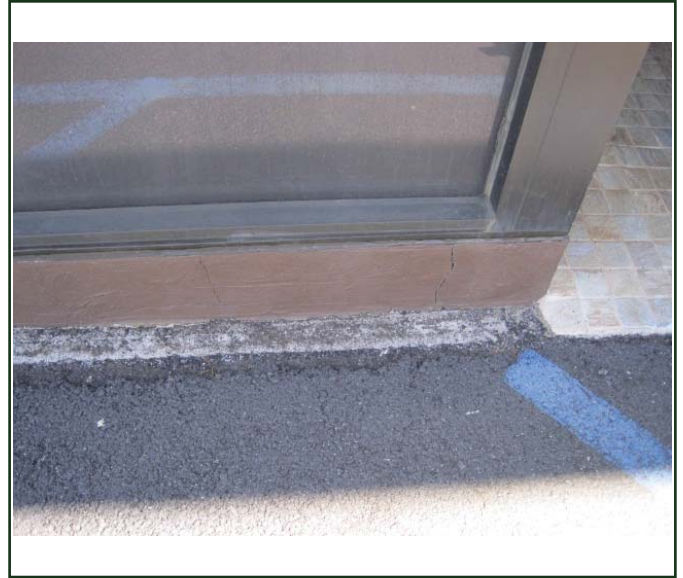
PHOTO 34: Spalling at front entry

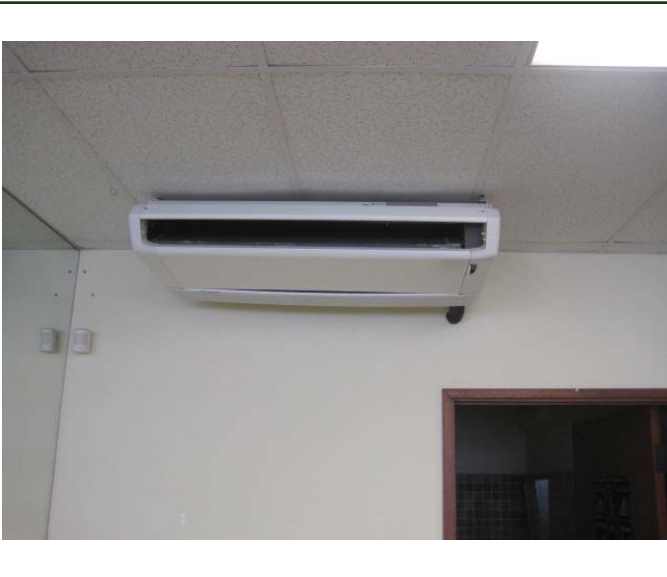
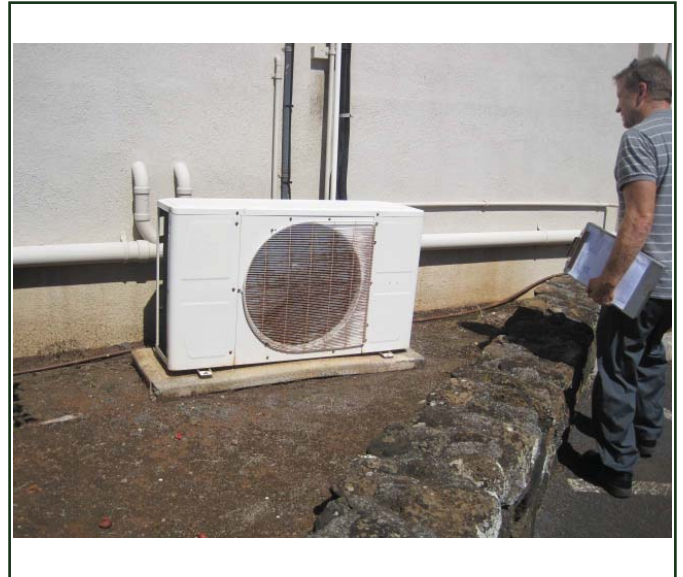
PHOTO 35: Abandoned split AC system
