# *HAWAII INSPECTION GROUP*

We have scanned the designated area of concrete floor at 123 Main Street, in Kahului, Hawaii, and the following is our findings.

## **SCOPE**

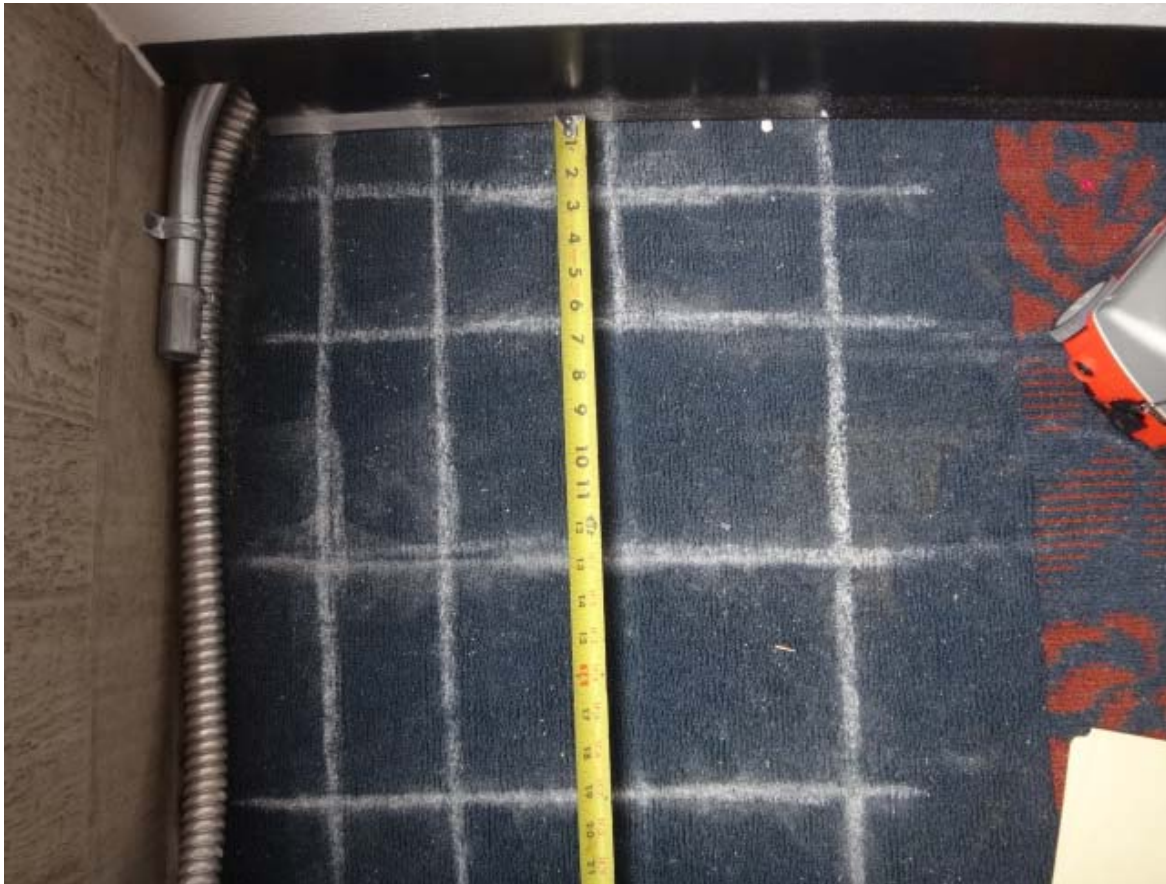
### **PHOTO 1 – North/South detections**

We found several anomalies running North-South in the concrete floor area that appeared consistent with structural steel (rebar, etc.), and these were detected at the following distances from the installed sheetrock wall at the East side of the scanned area, and at the following depths listed:

2 ½" from the sheetrock wall, @ approximately 2 1/8" deep from the surface of the installed carpeting on the floor in the area.

6 ½" from the sheetrock wall, @ approximately 2 1/8" deep from the surface of the installed carpeting on the floor in the area.

13" from the sheetrock wall, @ approximately 2 1/8" deep from the surface of the installed carpeting on the floor in the area.

19" from the sheetrock wall, @ approximately 2 1/8" deep from the surface of the installed carpeting on the floor in the area.

Locations of these detections were marked on the carpeting with chalk.

We recommend that any coring of the concrete material in the designated area be conducted in areas other than marked, and taking into account that we estimate our detections to be within +/- 1". If metal is suspected in the area to be cored, it is recommended that the area be chip-hammered to verify type and location prior to coring.

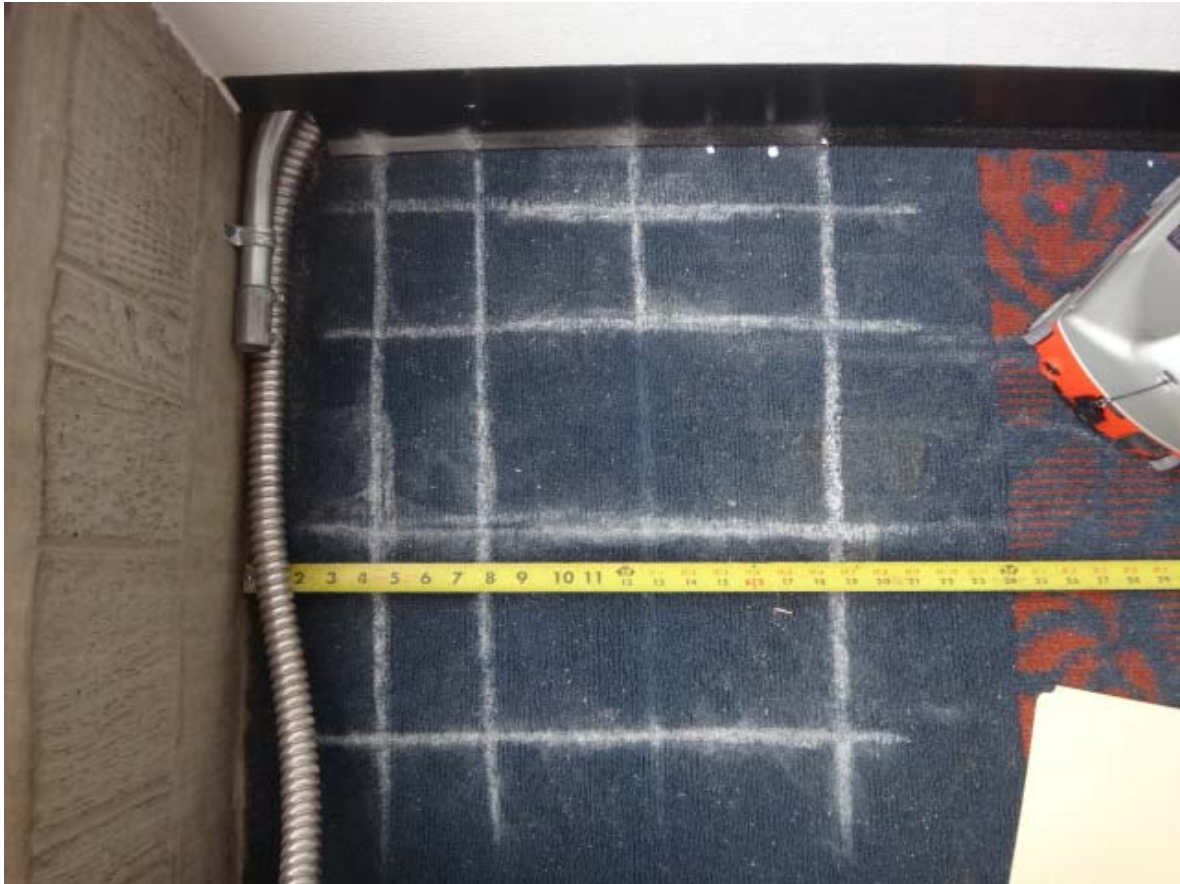
## **PHOTO 2 – East/West detections**

We also found several anomalies running East-West in the concrete floor area that appeared consistent with structural steel (rebar, etc.), and these were detected at the following distances from the exterior concrete wall at the North side of the scanned area, and at the following depths listed:

4" from the concrete wall, @ approximately 2 ¾" deep from the surface of the installed carpeting on the floor in the area.

7 ½" from the concrete wall, @ approximately 2 ¾" deep from the surface of the installed carpeting on the floor in the area.

12 ½" from the concrete wall, @ approximately 2 3/8" deep from the surface of the installed carpeting on the floor in the area. This anomaly appeared to end at a point of approximately 6 ½" from the sheetrock wall on the East side of the scanned area. (also see photo 1)

18 ¾" from the concrete wall, @ approximately 3 1/8" deep from the surface of the installed carpeting on the floor in the area.

Locations of these detections were marked on the carpeting with chalk.
