The Purpose of the PCA (Property Condition Assessment) is to observe and report, to the extent feasible pursuant to the processes prescribed within the ASTM E2018-01 guidelines, on the physical condition of the subject property.

Property Address: 111 Main Street

City, State, Zip: Wailuku, Hawaii

Survey Date: November 4, 2014	Time: 8:30 am	Report No:
Inspection Address: 111 Main Street		
City, State, Zip: Wailuku, Hawaii	Aprox. Sq. Ft.	20,801
Client's Name: Client: Apartment Ventures, LLC	Listing Inspection: <input type="checkbox"/>	(Due within 90 days)
Agent's Name:	Phone:	
Office:	Email:	
Inspection Cost:	Add:	For: GET
Paid On Site: <input type="checkbox"/>	Check No.	Billing Fee: \$0.00
		Total: \$0.00

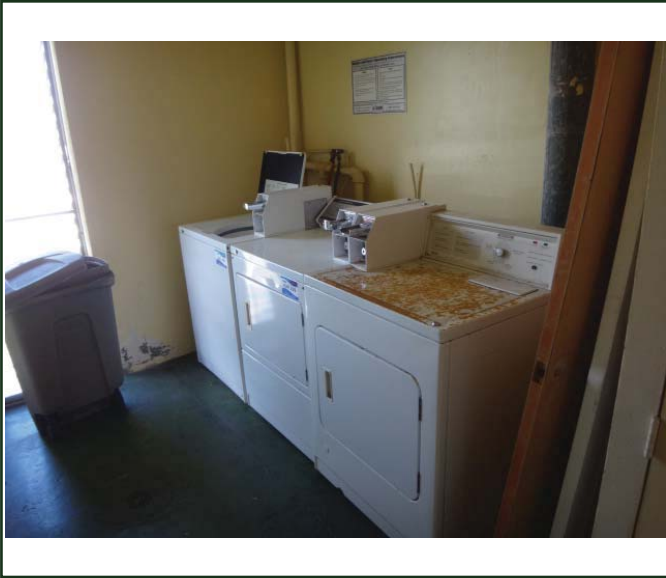
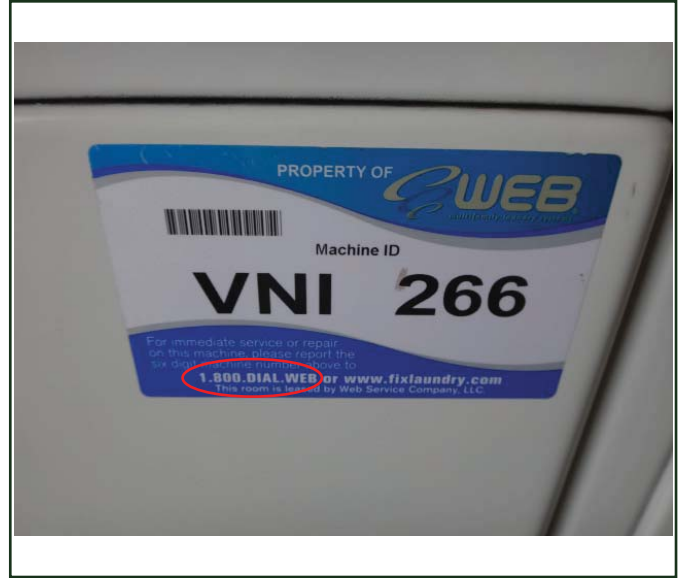
Coin-operated laundry equipment appeared leased through Web. (photos 13 & 14)

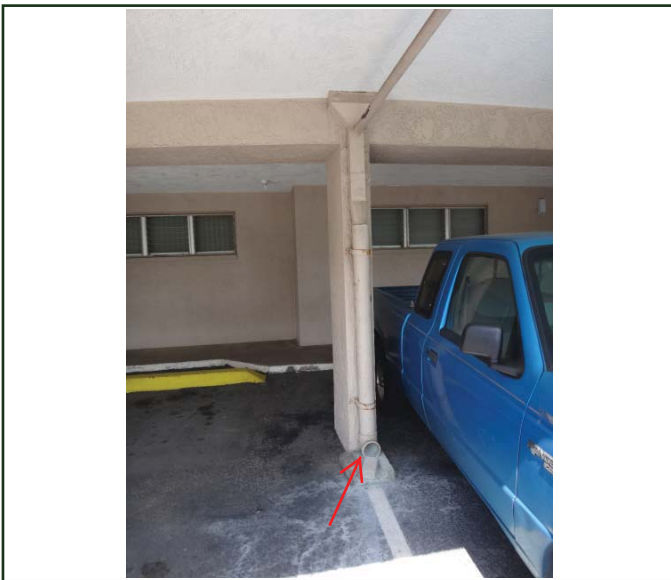
PHOTO 15:

Drainage for the property was on surface only. (photo 15)

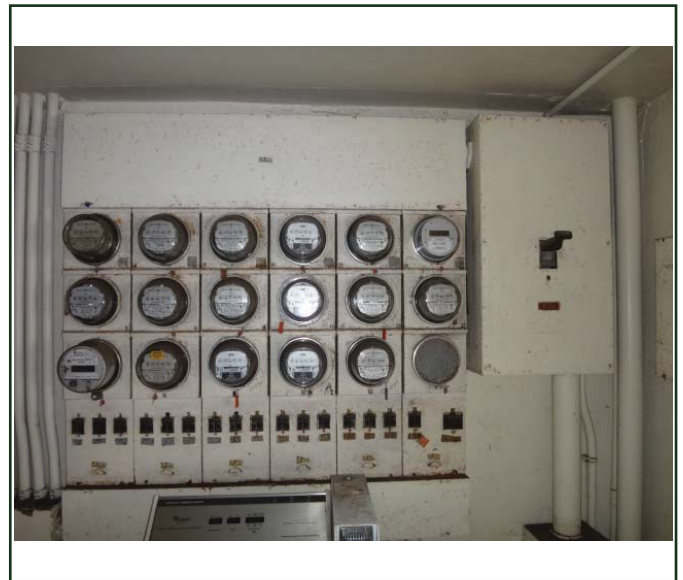
PHOTO 16:

The main electrical service entrance was in the electrical service/storage closet on the 1st floor in the center of the building, with electric meters and 100amp breaker disconnects for each of the 16 units and one "house" panel, and a main electric service disconnect (208v-600amp 1PH) in the same area. (photo 16) There was an electrical "house" subpanel (208v-125amp 1PH) located on the right wall near the main disconnect. (photo 17) The service and panels appeared original to the building, and showed some condition issues as described in section 3.7.4 Electrical.

- a) The metal cabinets for the main panel, unit meters and service disconnect breakers showed visible corrosion, and may need replacement within 10-15 years. These panels appeared original to the building, and upgrading the panels may save significant money in energy-efficiency savings. (photo16 & 17)
- b) The vast majority of the electrical outlets were worn and connections loose, with no GFCI outlets or circuits installed for the bathrooms and kitchen areas.

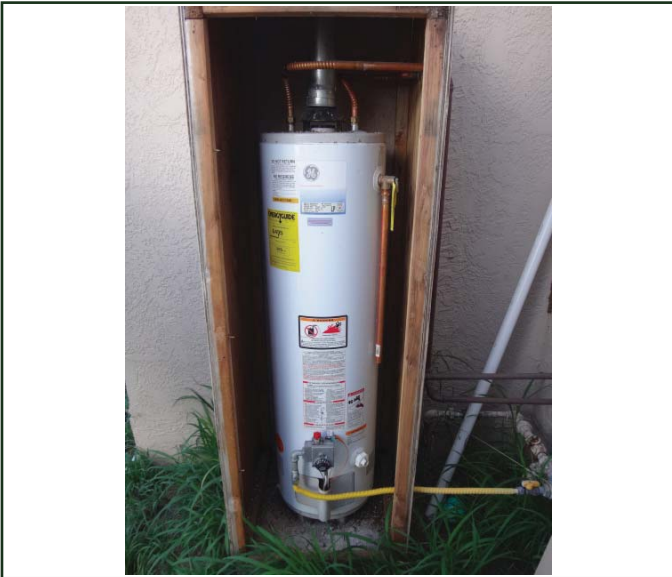
PHOTO 23:

The LP gas water heater (GE, estimated mfg. date 3/2010, 30 gal. capacity) was located at the exterior rear center of the building, and supplied hot water to the laundry equipment only. (photo 23)

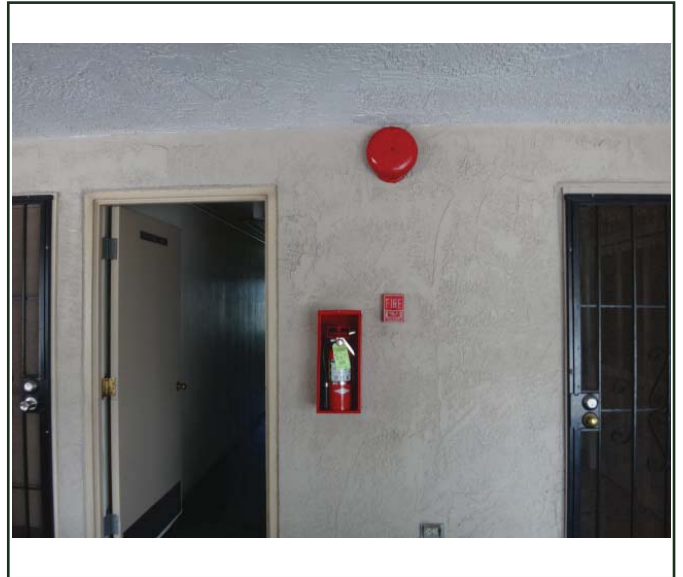
PHOTO 24:

There were 2 fire extinguishers and 2 pull stations with bells installed on the front of the building, and a reset panel installed in the electrical service area. (photo 24)
